Case Study Beneficial Use Sediments

Project	Slufter Sand Separation
Clssification	R1A_2006_NL
Major Funtion	Separating out clean sand from mixed contaminated sediments
Other Funtion	Providing a source of sediment for reuse in agriculture or engineering
Location	Slufter, Maasvlakte Rotterdam, The Netherlands
Volume	105,000 m³ (clean sand) from 160,000 m³ contaminated sediments
Technique	Use of sand separation basins to win back clean sands from contaminated
	dredged material
Contaminants	Contaminated with heavymetals and organic contaminants
Granulometry	Mixed Silty/sandy
Scale	Full scale (following trials in early 1990s)
Client	Port of Rotterdam Authority & Rijkswaterstaat
Executor	Port of Rotterdam Authority & Rijkswaterstaat
Contractor	N/A
Research program	N/A
Contact	Ronald Rutgers, Port of Rotterdam Authority
	R.Rutgers@portofrotterdam.com , 🕾 +31(0)651821857
Year start - end	2006 to 2014

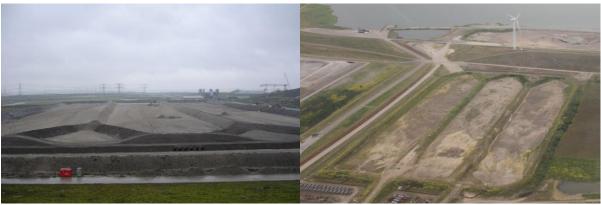
Figure 1: Construction of the sand separation basins (2006) Figure 2: Aerial view of the basins (2017)

In general, many contaminants (except perhaps mineral oil and PAHs) tend to stick to finer silt and clay particles rather than coarser sandy sediment. Using this principle it is possible to derive clean sand from mixed contaminated sediments through a process of 'sand separation'. This is done at the 'Slufter' at the *Port of Rotterdam*. Since 1993 pilot projects have been undertaken while in 2006 construction started on three large sand separation basins.

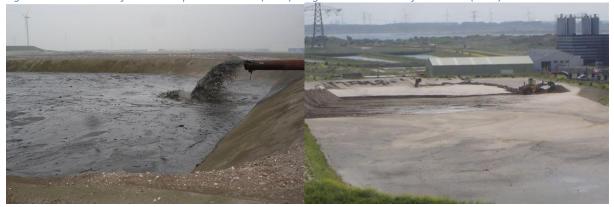
Figure 3: Filling the basin

Figure 4: removing clean sand from the basin

The principle of the basins is simple. Firstly, a mixture of dredged sediment and water is pumped in at one side and allowed to flow to the other side. As the slope is 1:35 to 1:20, the mixture moves slowly enough to let sand particle settle but keep clay/silt in suspension. At the end of the basin the 'water-sediment mixture' passes into a discharge ditch from where it is pumped to a storage location. This process is performed until the basins are completely filled with sand.
