## Case Study Beneficial Use of Sediments

<b>Project</b>	<i>Sandvika Marina Harbour</i>
Classification	<i>R3B_2010_NO</i>
Major Function	<i>Reclamation</i>
Other Functions	<i>Raw material, Remediation</i>
Location	<i>Oslo, Norway</i>
Volume	<i>4,000 m<sup>3</sup></i>
Technique	<i>Mass stabilisation of contaminated sediments with hydraulic binders</i>
Contaminants	<i>Tri-butyl tin, As, Ni, Cu, Hg, Pb, Cr, Zn, Cd, PAH</i>
Granulometry	<i>Silty clay</i>
Scale	<i>Full scale</i>
Client	<i>Sandvika Municipality, Oslo, Norway</i>
Executor	<i>Contractor: Ramboll</i>
Research program	<i>N/A</i>
Contact	<i>Norwegian Institute for Water Research, NIVA.</i>
Year start - end	<i>2010</i>
<b>Description of the project</b>	
<p>Contaminated sediment from the Sandvika River seabed in the Oslo fjord was removed by dredging and stabilized by mixing with a GGBS plus cement-based binder and used in the construction of a new quay wall. Approximately 4,000 m<sup>3</sup> of sediments were dredged by a mobile crane and grab, and placed behind a concrete sheet pile wall, where mass stabilisation was carried out by injecting and mixing the GGBS/cement binder with the dredged sediments.</p> <p>The stabilised

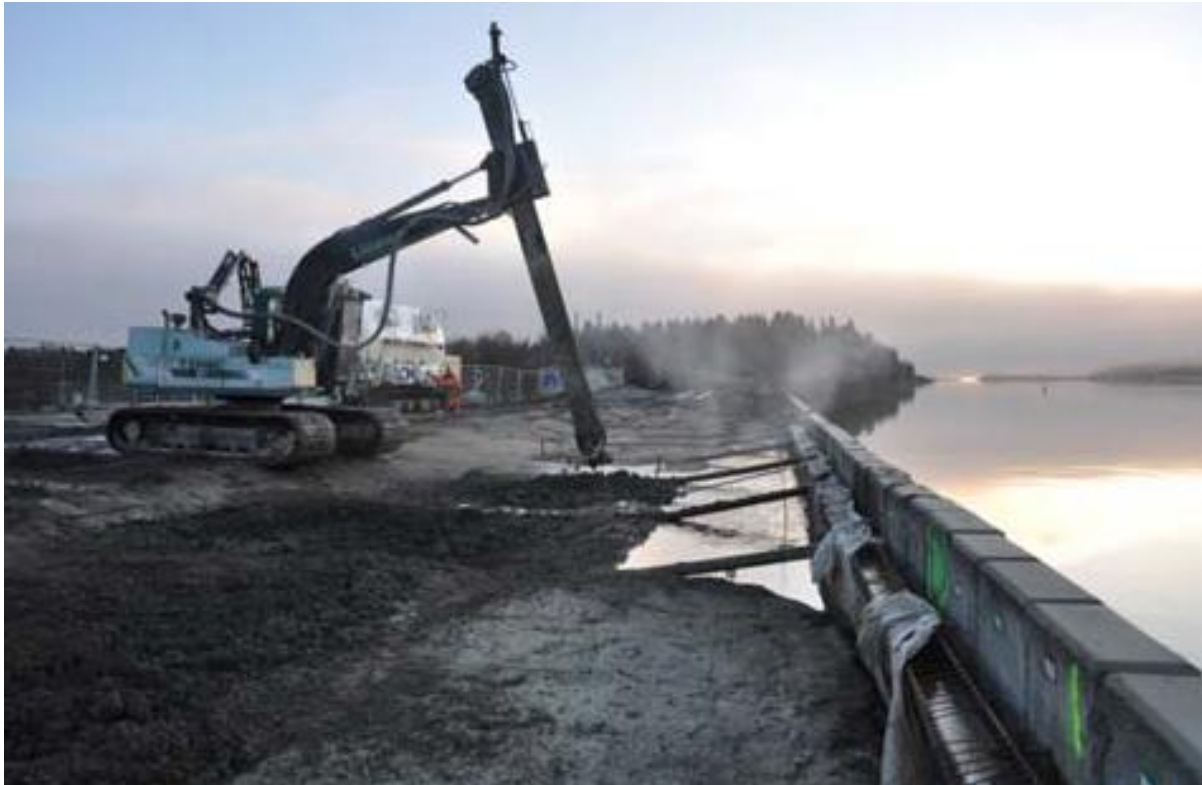
Figure 1. Mass stabilisation of dredged contaminated sediment behind concrete quay wall

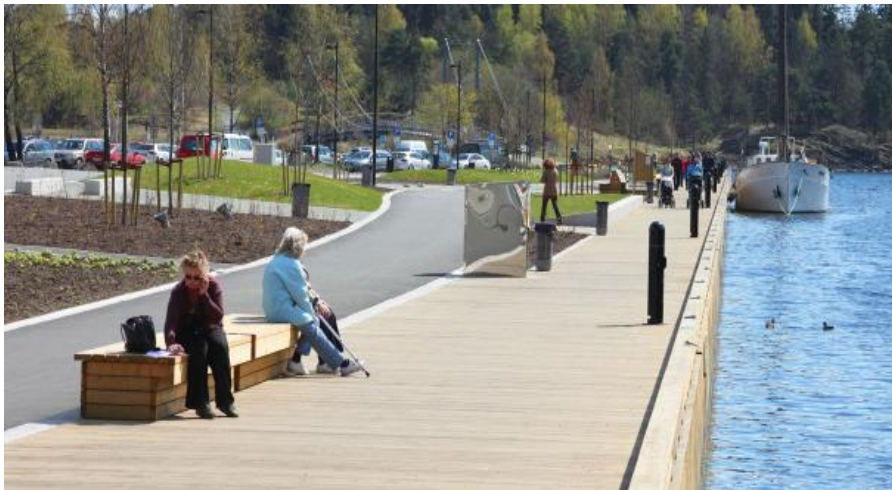
Figure 2. Completed project – stabilized sediments form new quay wall and walkway
