## Case Study Beneficial Use of Sediments

<b>Project</b>	<b><i>Beach Replenishment and Lagoon Restoration</i></b>
Classification	<i>R4C_2007_US</i>
Location	<i>San Elijo Lagoon Ecological Reserve, Southern California, USA</i>
Major Function	<i>Restoration</i>
Other Functions	<i>Resilience</i>
Volume	<i>344,000 m<sup>3</sup></i>
Technique	<i>Remediation of Estuary Sediments with Beach Replenishment</i>
Contaminants	<i>Clean material placed on the beach, contaminated sediment sequestered</i>
Granulometry	<i>Sand</i>
Scale	<i>Full Project</i>
Client	<i>San Elijo Lagoon Conservancy</i>
Consultant	<i>Consultant: Moffatt &amp; Nichols; Contractor: Marathon Construction</i>
Research program	<i>North Coast Corridor Project (Infrastructure)</i>
Contact	<i>Nick Buhbe, Mission Environmental, <a href="mailto:nick@missionenv.com">nick@missionenv.com</a>, +16199859111</i>
Year start - end	<i>2007</i>
<b>Description of the project</b>	
<p>This restoration project is a component of an infrastructure project to upgrade a road and rail crossing of the San Elijo Lagoon (an Ecological Reserve) in southern California. One area includes sediments contaminated by historical sewage ponds which are an ong

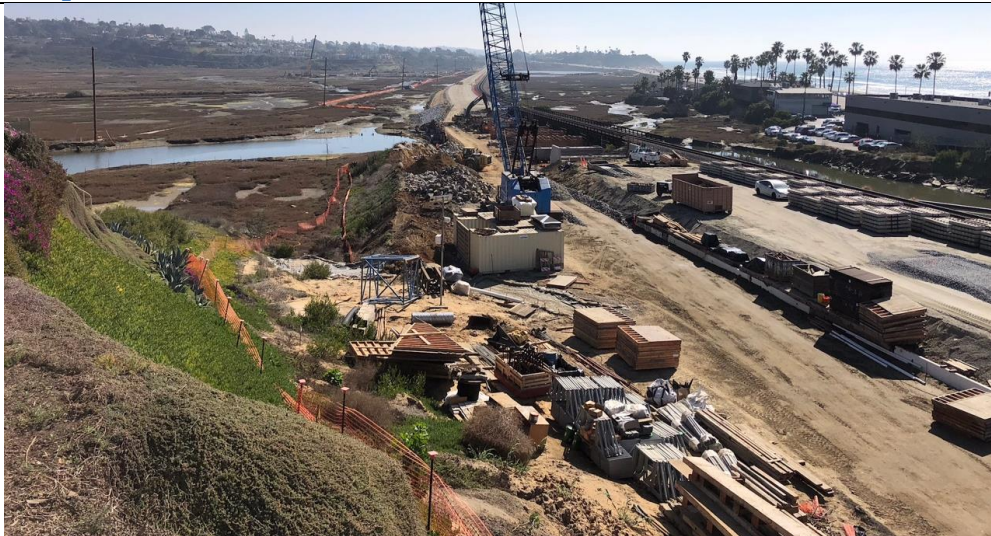
Figure 1. Rail Corridor Construction (foreground), with Containment Pit in Preparation ( background)

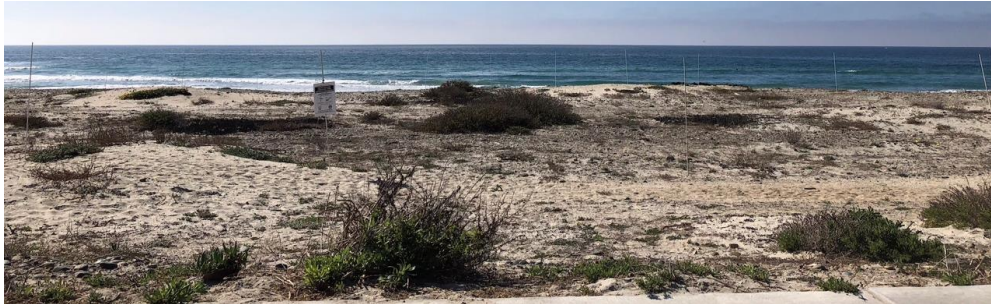
Figure 2. Low Dune Habitat Restoration, San Elijo State Beach

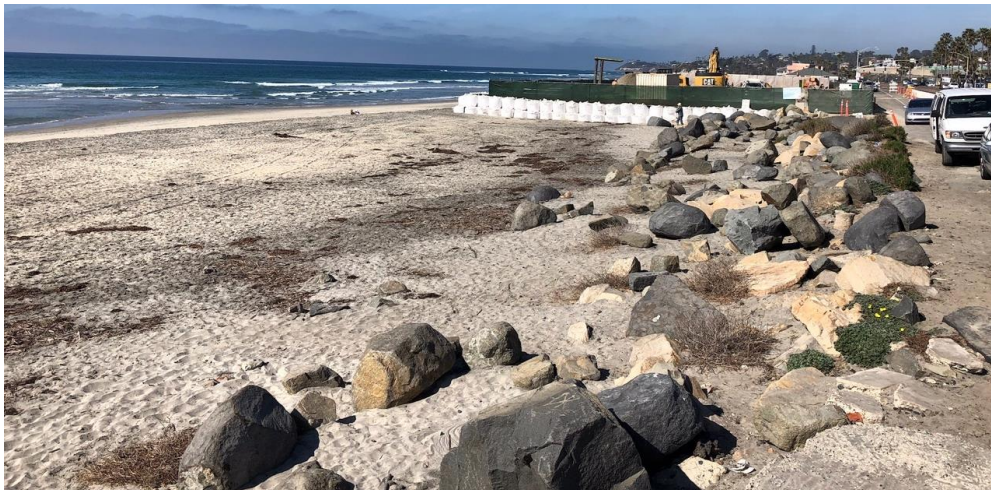
Figure 3. Sediment Stockpiling and Staging Area, San Elijo State Beach
