## Case Study Beneficial Use of Sediments

<b>Project</b>	<b><i>Deer Island Aquatic Ecosystem Restoration Project</i></b>
Classification	<i>R5B_2010_US</i>
Major Function	<i>Restoration</i>
Other functions	<i>Resiliency</i>
Location	<i>Deer Island, Mississippi Sound, Biloxi, Mississippi, USA</i>
Volume	<i>1.95m cubic yards sand</i>
Technique	<i>Strategic placement of dredged and borrowed material</i>
Contaminants	<i>N/A</i>
Granulometry	<i>Sands and silts</i>
Scale	<i>Reclamation, restoration and maintenance dredging</i>
Client	<i>USACE Mobile District, Mississippi Department of Marine Resources (MDMR)</i>
Executor	<i>Mike Hooks Incorporated, (dredging); Fish Tec Incorporated (geotubes); RCG-Quality Enterprises and Tropical World Construction (vegetation).</i>
Research program	<i>N/A</i>
Contact	<i>Dr Todd Bridges, at <a href="mailto:Todd.S.Bridges@usace.army.mil">Todd.S.Bridges@usace.army.mil</a></i>
Year start – end	<i>2010 - 2013</i>
<b>Description of the project</b>

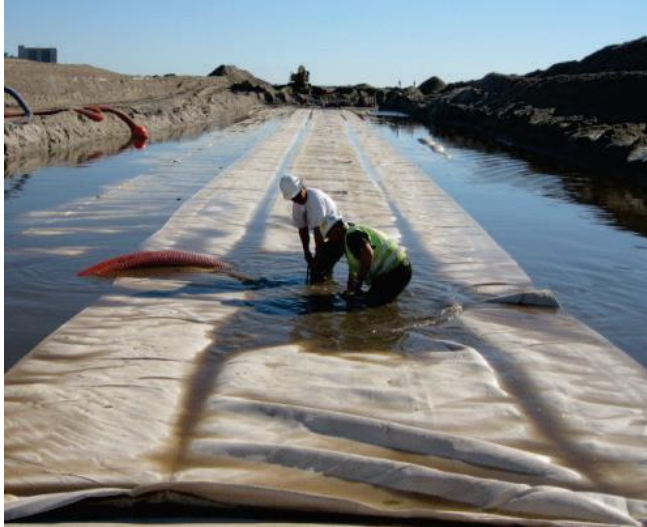
Figure 1. Filling of geotubes with sand, underlying the western breach.

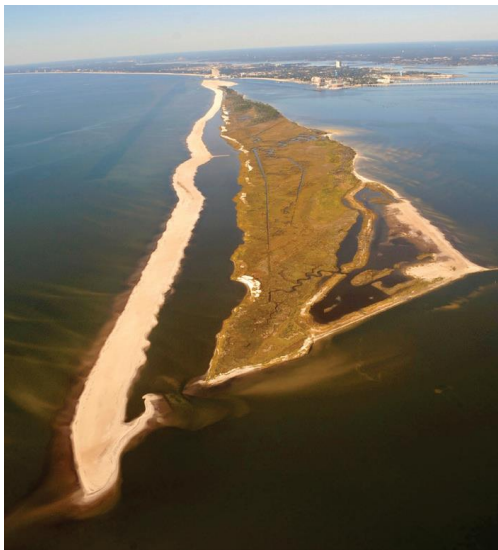
Figure 2. Re-built southern shoreline, separated from main spit by a long narrow lagoon
